By Donnie Garcia and Gianni Filippi
Microcontroller Applications Engineering
Austin, Texas

Introduction and Background

Definition of Early TOF

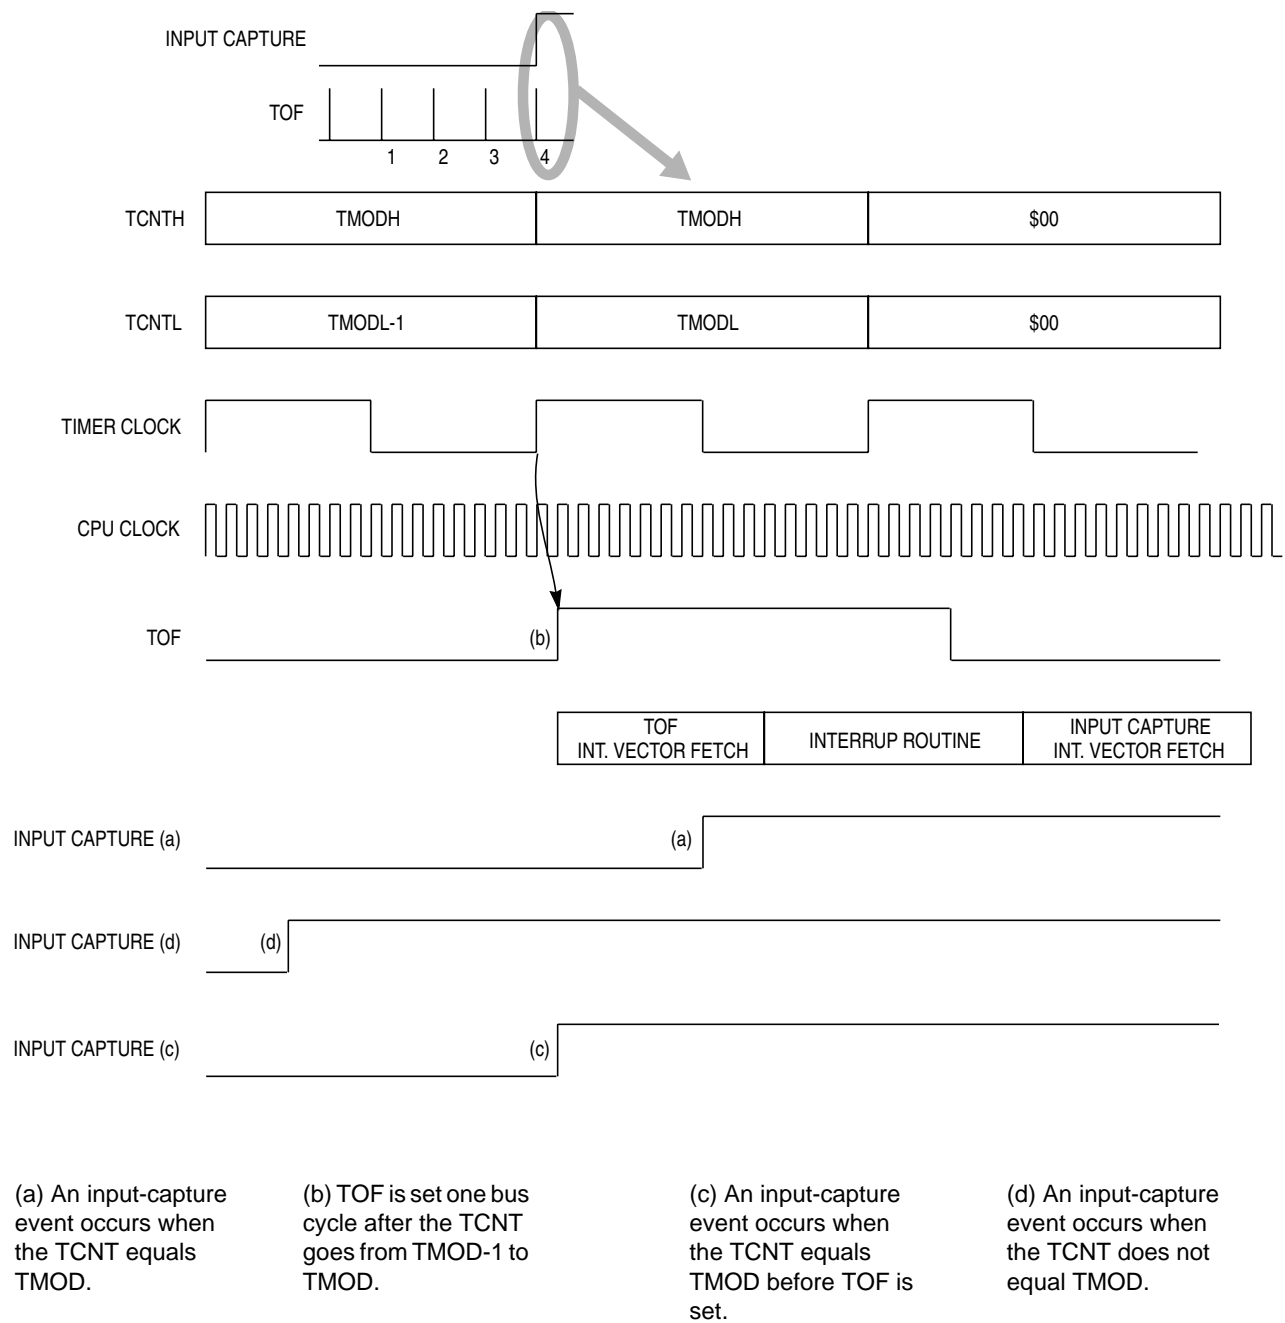
To accomplish this, a counter must be placed in the timer overflow subroutine. Every time the overflow interrupt occurs, the counter is incremented to keep track of the number of overflows. The early TOF arises because the overflow interrupt occurs soon after the timer reaches the value in the timer counter modulo register, as stated in the Interrupts section of the *TIM08 Timer Interface Module Reference Manual*. When this occurs, the overflow counter can be incremented before the timer counter reaches its next state (\$0000). This leads to an inaccurate count of the number of overflows that have occurred if an input capture occurs during the Modulo transition time. See [Figure 1\(a\)](#).

Figure 1. Early TOF Cases

It turned out that the priorities are respected, but the TOF is set when the TIM 16-bit counter reaches the modulo value, rather than when it resets to \$0000 after reaching the modulo value programmed in the timer counter modulo register. For example if the timer counter modulo registers (TMODH and TMODL) contain \$FFFF, the TOF is set when the timer counter goes from \$FFFE to \$FFFF. See [Figure 1\(b\)](#). The timer overflow interrupt service routine will then be entered and no other interrupts will be granted until that one is completed. Therefore, if an input-capture signal occurs, it will not trigger an immediate interrupt service routine, even if the channel interrupt has a higher priority than the overflow one. However, if the channel receives an input signal while the timer counter is counting \$FFFF, a time measurement error will occur. See [Figure 1\(a\)](#). As the timer clock source can be divided by the internal bus clock (by 1, 2, 4, 8, 16, 32, 64 or be driven by the TCLK pin), this error will appear when the timer clock source is set to a value significantly slower than the internal bus clock. In fact, only in those circumstances will there be a chance of experiencing an early TOF.

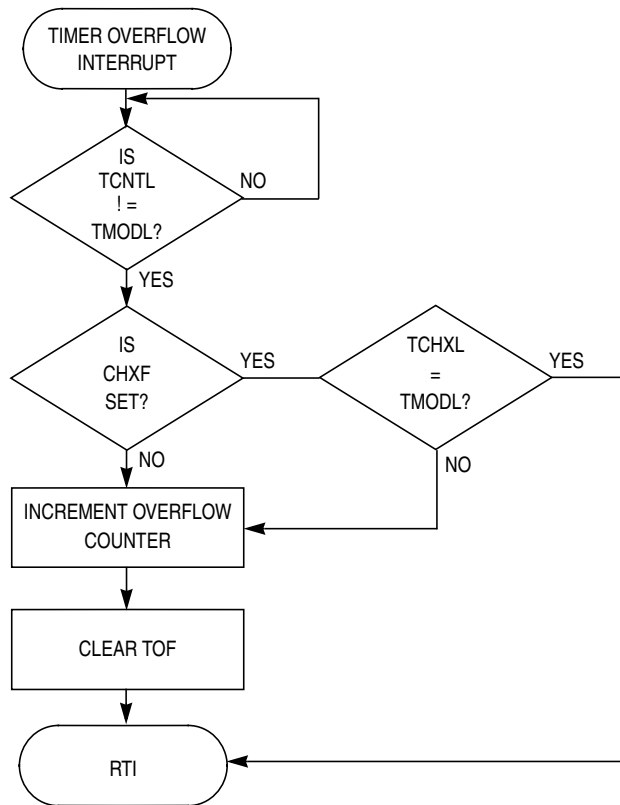
Figure 2. Overflow ISR Technique Flowchart

To ensure correct timing calculations, modify the overflow interrupt service routine (ISR) to detect whether an input capture signal occurred while the timer counter was at the timer modulo value. If this is the case, the overflow interrupt service routine will be aborted and the program will return to the main. See [Figure 2](#). Then it will enter the input capture interrupt service routine, because it is a higher priority than the overflow. After that, the program will return to the previously aborted overflow interrupt service routine. Therefore, a miscalculation of time will not occur.

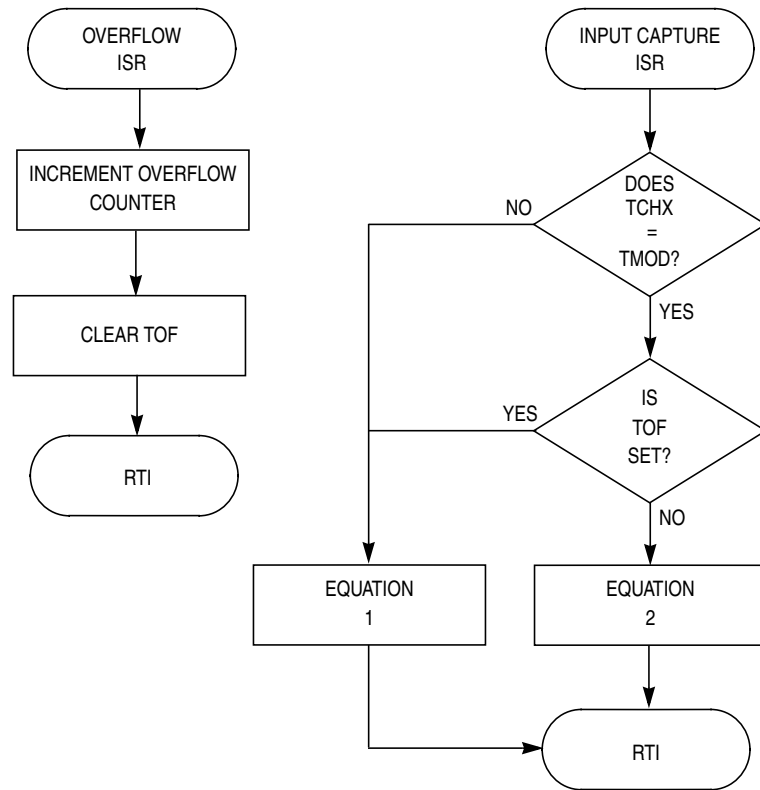
Figure 3. Input Capture ISR Technique Flowchart

The input capture ISR software solution does a series of checks once an input-capture interrupt occurs to resolve the early TOF behavior. From examination of the timer, it was determined that the early TOF occurs soon after the timer reaches the value in the timer counter modulo register. Thus the first check that the input capture ISR does is to see if the contents of the timer channel register contain the value in the timer counter modulo register (the input capture occurred at the value in the timer modulo register). See [Figure 1\(a\)](#). If the input capture did not occur at the value in the timer counter modulo register, then the normal calculation of the input capture time should be done. See [Equation 1](#). If the input capture did occur at the value in the timer modulo register, then the software must handle two special cases. Case one is when the TOF interrupt occurs, and then an input capture occurs when the timer is still at the value in the timer counter modulo register. See [Figure 1\(a\)](#). This is the early TOF condition. The calculation of the input capture time is done with [Equation 2](#):

This equation accounts for the extra overflow in the overflow counter. Case two occurs when the timer reaches the value in the timer modulo register and an input capture occurs before the TOF interrupt. See [Figure 1\(c\)](#). This case must use the normal calculation of the input capture time, [Equation 1](#). These two special cases are handled using the status of the TOF flag in the timer status and control register. Refer to the flowchart in [Figure 3](#). The C code is shown here.
